ENVIRONMENTAL PROTECTION AGENCY, STATE OF ILLINOIS

INSPECTION REPORT - SITE INVENTORY NO.

Lockport

1 Wasteland

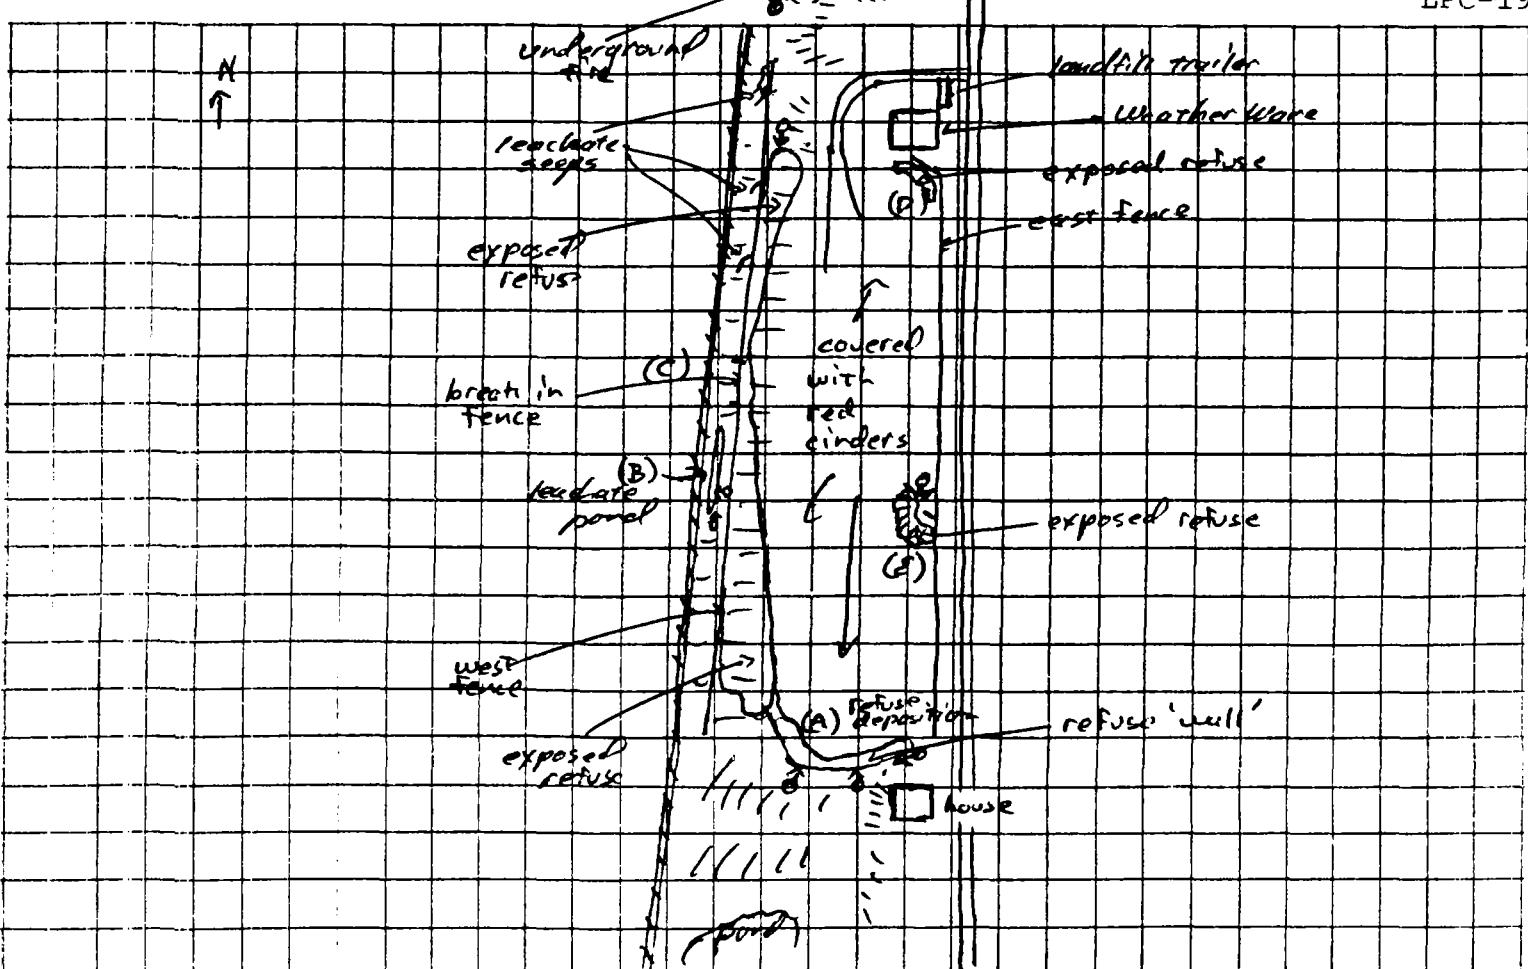
DIAGRAM:

- at (A). Refuse from this fill area was contiguous with exposed refuse refuse along the southern edge of the active lift and on the west slope of the landfill, above the west fence. In similar fashion as to that described in the 4/12/82 report, incoming refuse is deposited atop the edge of the active lift, which is still progressing southward, and pushed over the edge of the lift by the one cat working there. A resultant "wall" of refuse, from approximately 10 to 15 feet high, was found. ~~approximately 15 feet high.~~ (AS)

- Leachate was found ponded in the railroad right-of-way, at (B). The liquid possessed a orange surficial film with a metallic sheen, the underlying solution was turbid, a definite leachate-like odor accompanied the liquid. This pond was sampled. It was located ~~at~~ roughly between 30 and 5 feet from the edge of the railroad track.

- Leachate was also found seeping along the west slope. A few ^{seeps} were found just below the west fence, north of the break at (C). Others were found around the north terminus of the west fence.

- ^{other} 2 areas of exposed refuse were seen, one at the northeast corner at (D), and one in the depressed area around the culvert at (E). Paper and cardboard were the predominant refuse types here.

- Paper, cardboard and domestic refuse and garbage predominated among the types of refuse noted along the south edge of the active lift and the west slope. Tires, scrap wood and metal were also present, approximately 5yd³ of Pilet refuse was spread near A.

- At (F), a small hole was found in the cover in which a copious amount of smoke, which smelled like burning papers, was emerging.

The clay and rock around the hole was covered with an apparent black soot material. Lesser amounts of smoke was also seen emerging from a few cracks in the near vicinity of this hole. When this was mentioned to Tom Barnette, the cut operator, at the completion of the inspection, he replied that this was probably from the fire which occurred here about a year ago. He also said he would be digging up the area and putting a good seal of clay over it.
